Manuscript number	IJRMMS_2018_1176_R1
Title	Failure mechanisms and stability analyses of granitic boulders focusing a case study in Galicia (Spain)
Article type	Research paper

Failure mechanisms and stability analyses of granitic boulders focusing a case study in Galicia (Spain)

I. Pérez-Rey¹, L.R. Alejano¹, A. Riquelme², L. González¹

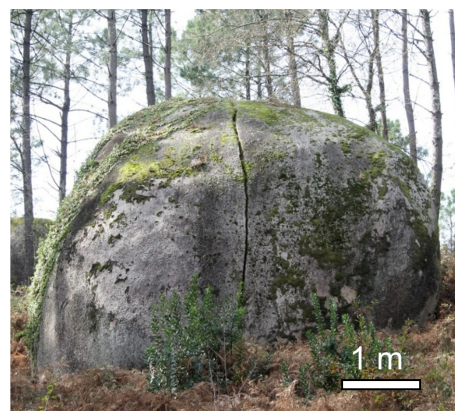
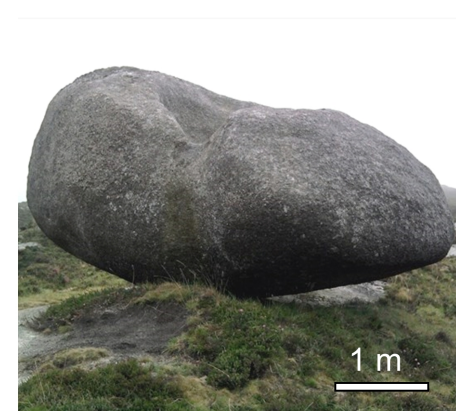
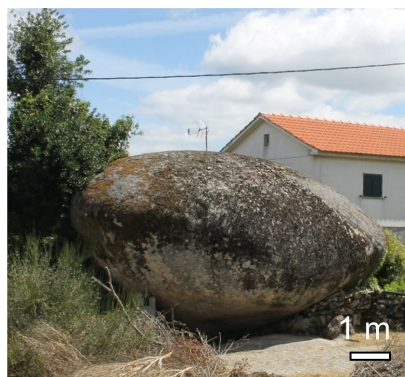
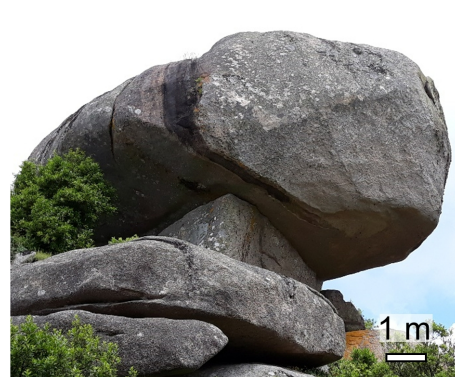
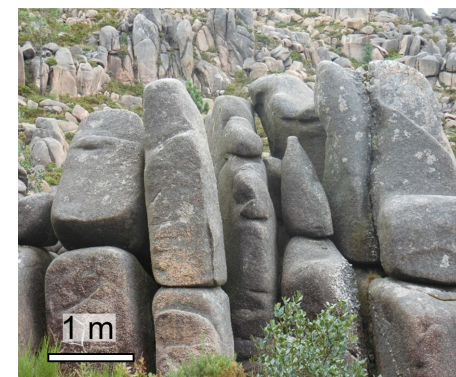
Figure 2. Different examples of granitic boulders in the NW Iberian peninsula: (a) ellipsoidal boulder still surrounded by highly decomposed granite; (b) quasi-spherical boulder recently released from completely decomposed granite; (c) boulder presenting a sub-vertical crack; (d) ellipsoidal rocking stone, something attributed to a concave base; (e) twin boulders; (f) large boulder probably fallen down from a close mountain; (g) very large boulder (10,000 tons) in a mountain peak and (g) slab-like rounded cornered blocks. Location of every boulder written below every picture and approximate scale reflected. All pictures by authors.

On some occasions, granitic boulders can be encountered either isolated or clustered but displayed as balanced rocks, that's to say, potentially close to a limit-equilibrium state (**Figs. 2d** and **2g**). This fact may imply an instability hazard, incremented by the huge size reached by some of these structures —i.e. *The Leviathan* boulder²⁵, with an approximate length of 33 m— but, essentially, due to their possible location at spots presenting steep slopes. These features could eventually lead to instability, and sometimes subsequently to a rockfall event, representing a threat for any structure or population located in the falling path.
